**4TH INTERNATIONAL
CONFERENCE WOOD IN
WORLD RIVERS 2019**

**Field Trip Guide for Ensenada/Calbuco
Post-Conference tour for Wood in World Rivers 4 Conference – Jan 10-11,
2019**

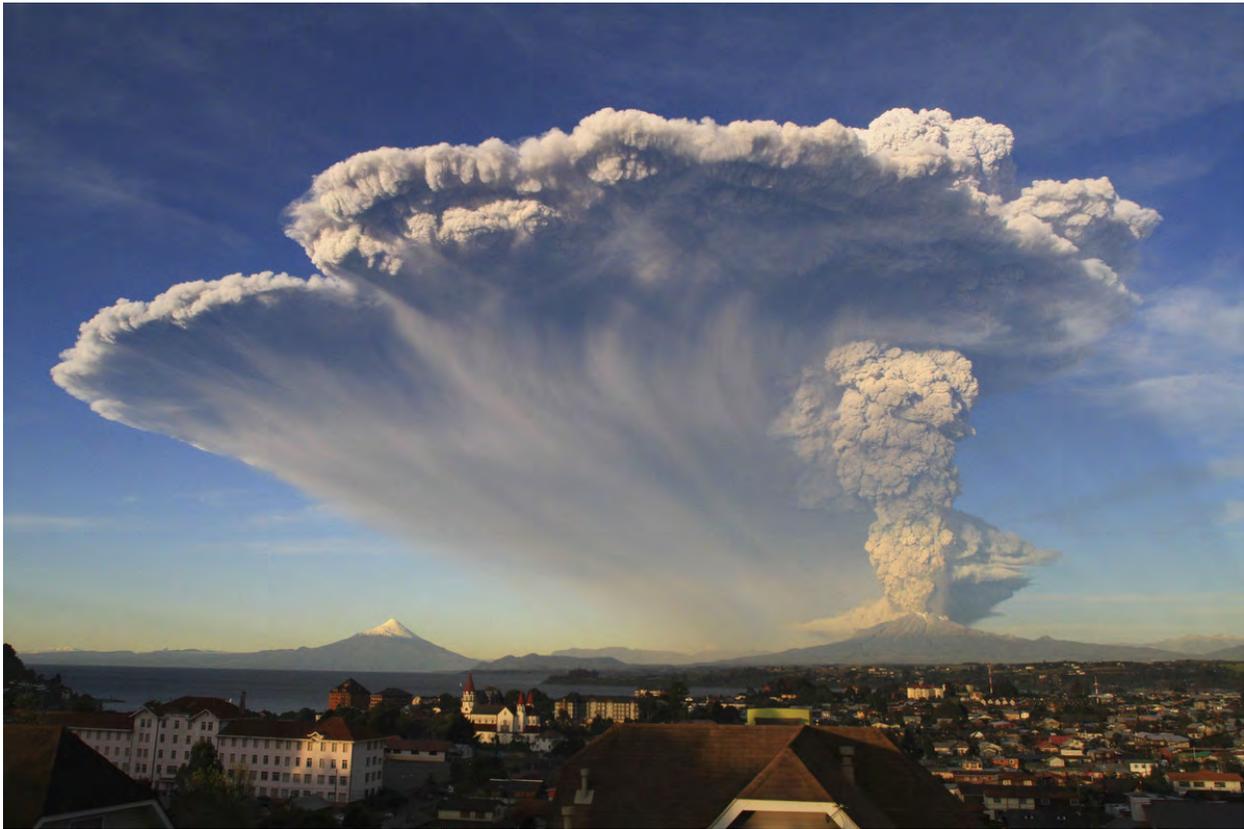
Calbuco volcano during the April 2015 eruption. Photo from the city of Puerto Varas looking to the east, with the Osorno volcano to the left (source, Gutierrez, 2015)

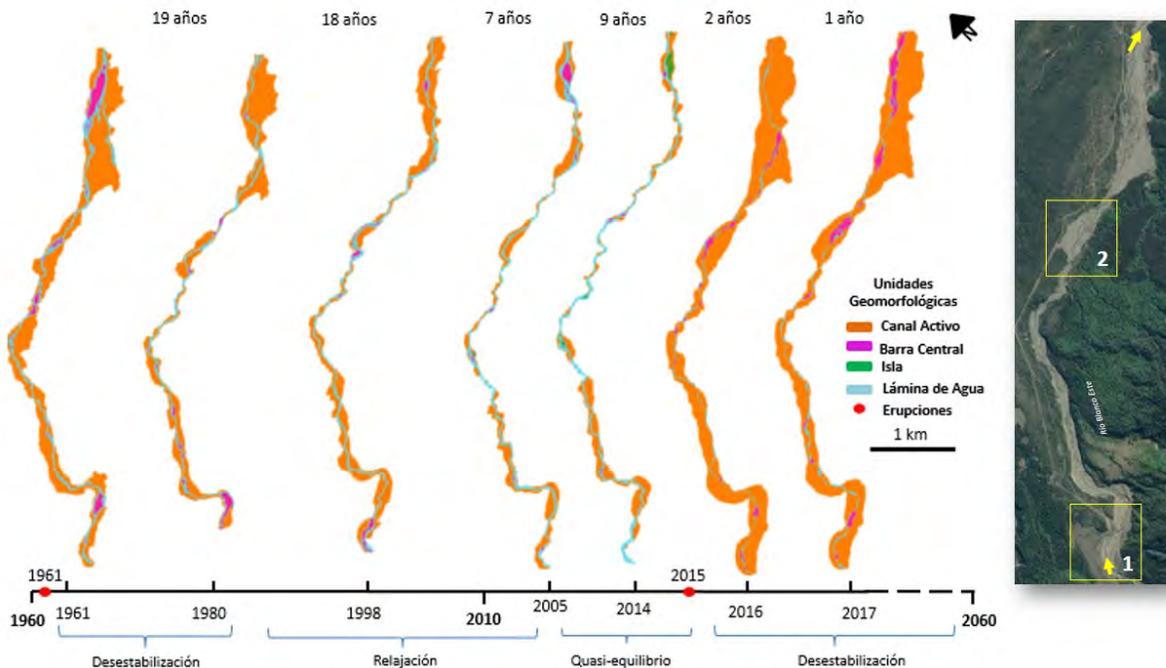
Fig. 2. The Blanco-Este River from a sequence of remote images, from 1961 (just after the 1961 eruption) to 2017 (after the 2015 eruption). (From Valeria Zingaretti, MSc Thesis).

Valley floor dynamics from 1961 to 2018 are revealed in aerial photographs (Fig. 2, Valeria Zingaretti, UACH). The fluvial system experienced dramatic vertical and lateral changes in response to the 1961 and 2015 eruptions. Various methodologies and instruments are deployed in this area to observe system dynamics. Remote images, drone images, field work with differential GPS (dGPS), terrestrial laser scanner, grain size, and geophysical surveys are used to observe sediment deposit characteristics, and time lapse cameras are deployed to investigate flood patterns. In the upper site of the Blanco-Este River, Andy Russell and colleagues installed a solar-powered monitoring system in January 2018.

- Setting the stage. Earlier history of river channel change and revegetation is revealed in a sequence of photographs beginning after the 1961 eruption (Fig. 2). This site is downstream of the extent of hot and cold volcanic flows, but they left a large volume of readily mobilized material upstream, so aggradation and channel widening has been dramatic. These processes overwhelmed a hydropower plant constructed at this site before the eruption (Fig. 4).

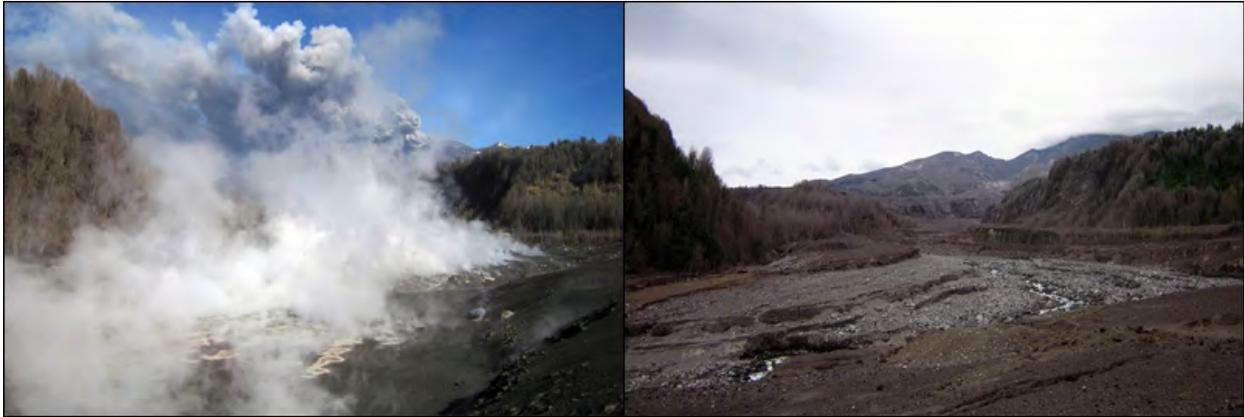
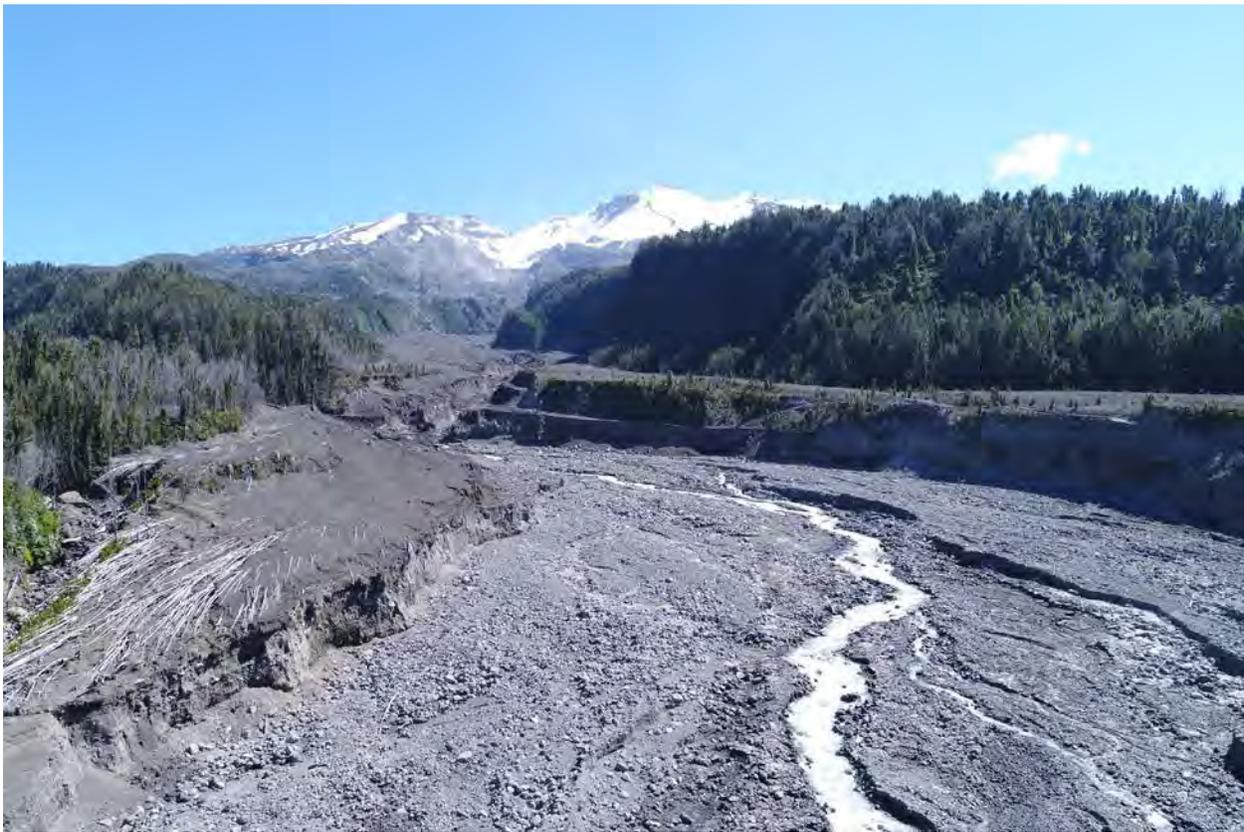
Fig. 3. The upper Blanco-Este River site. Above left, few days after emplacement of pyroclastic flows and lahars showing vigorous fumarole activity (May 2015) and above right after extensive fluvial erosion of the flow deposit (Jan. 2016). (photos by J. Romero).

Above, drone image of Stop 1 (A. Iroume, December 2017).

Stop 1. Blanco-Este River upper site (Fig. 1). Initial eruption impacts and fluvial geomorphic dynamics, including large wood (Fig. 3). Viewed from this location the Calbuco cone is quite irregular in form, complicating the pattern of rivers draining its summit area. Main presenters: Andres Iroumé (UACH, Chile), Andy Russell (Newcastle, UK), and Alejandro Dussailant (U Aysen, Chile).

- Research program and findings.
 - Fluvial geomorphology. Field observations indicate that river bed incision dominates fluvial processes in this upper reach, suggesting that the channel is a massive source of sediments. Grain size is highly varied and no final river configuration (i.e., step-pool, riffle-pool) has yet been established. The river is still far from reaching a *quasi-equilibrium* state.

- Effects on wood in the river. There is little wood on the recently emplaced sediment at this site, perhaps because upstream sources are limited, and wood delivered to this site may have been transported through this reach and delivered to downstream reaches, such as at Stop 2.

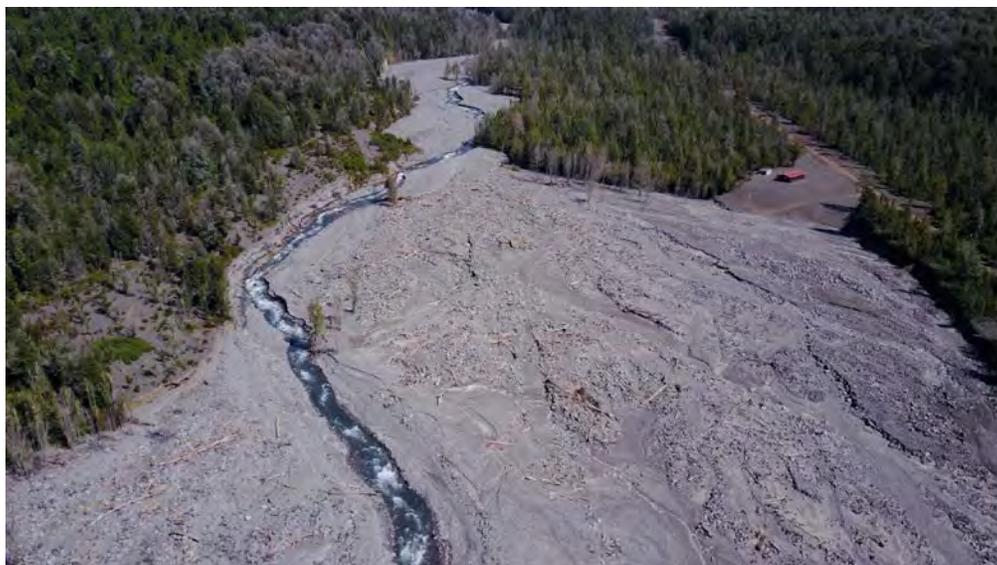
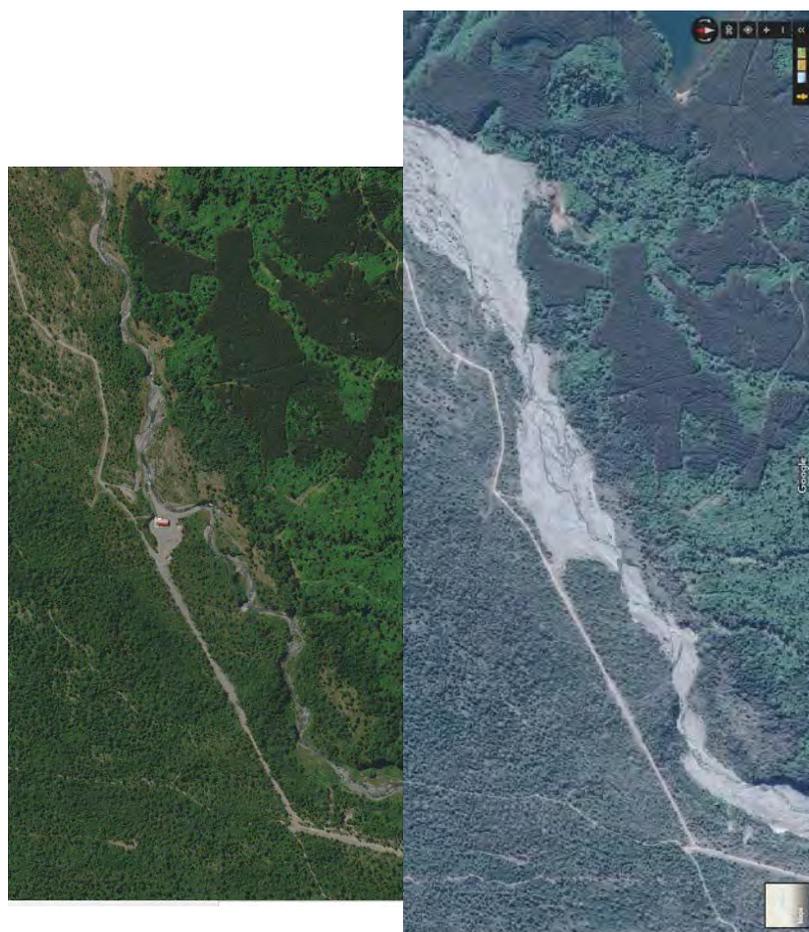
Fig. 4. Above, drone image of Stop 2 channel conditions (A. Iroume, April 2017). Below, Blanco-Este River before (left, DigitalGlobe, 2014) and after (right, Google) the 2015 eruption.

- Research program and findings.
 - Fluvial geomorphology. This site is characterized by the enormous sedimentation that has occurred since the eruption, which is shown by the braiding and the rapidly changing character of the channel, as well as by the poor sorting of the sediments. Channel morphology and sedimentary characteristics may suggest that this reach is accommodating a large part of the sediments eroded and transferred from upstream that are circulating through the river mainstem since the eruption took place. A big sediment pulse is moving along the river's longitudinal profile, with this middle reach acting as a large sediment sink, hence aggradation mainly occurs. For example, in the period 11 April 2017 to 2 August 2017 the bed aggraded by up to 3 m and the channel eroded laterally by up to 30 m (Fig. 5). Thanks to the on-going, long-term analysis that we have undertaken, we can hypothesize that it will take decades until the river re-attains a *quasi*-equilibrium state, especially in highly dynamic reaches such as this one.

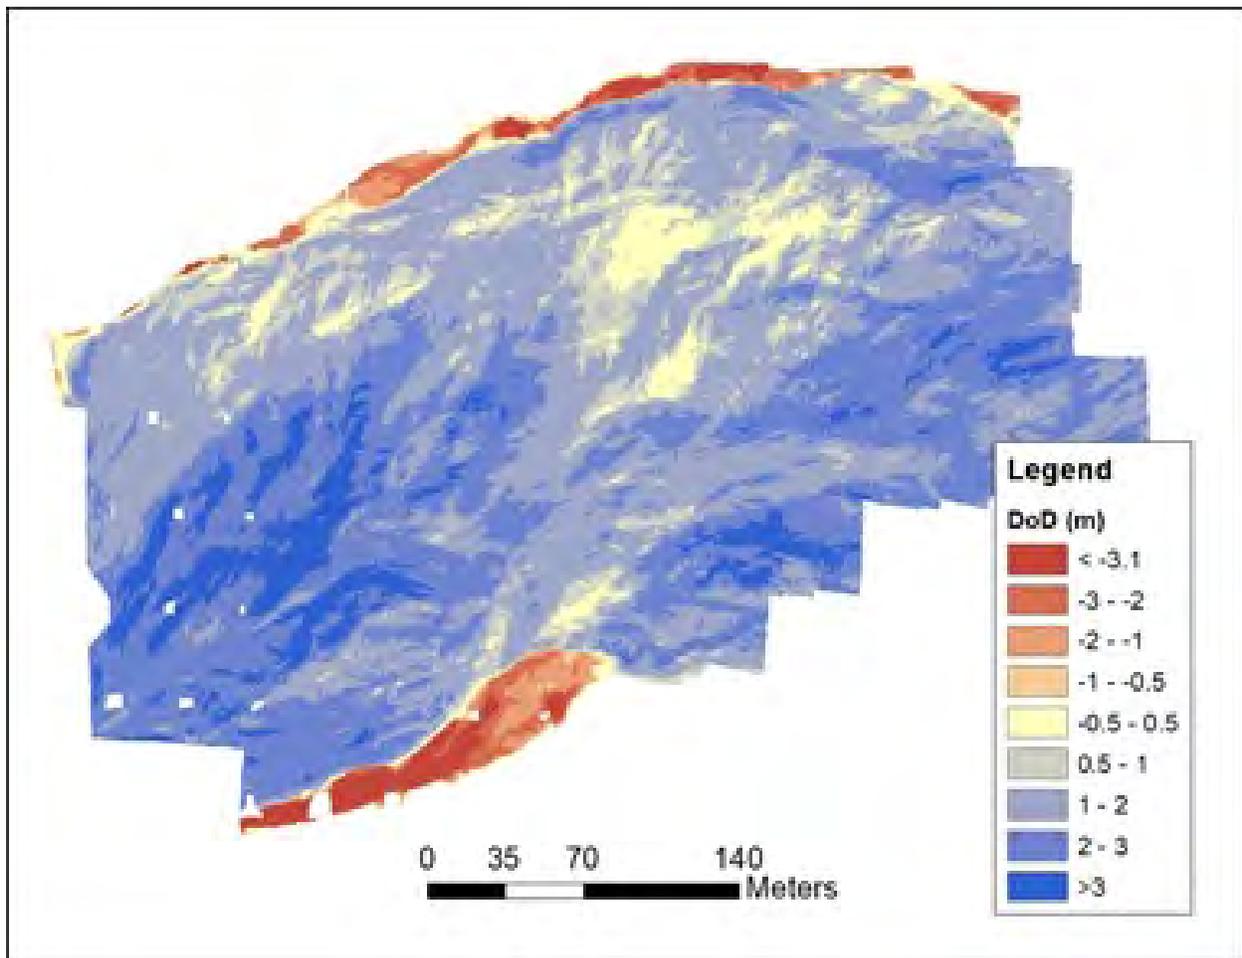
Fig. 5. Raw difference of DEMs (DoD) between 11 April 2017 and 2 August 2017 of the Stop 2 site. The colors displayed represent net change in elevation (meters). Negative values represent erosion (nearly entirely bank erosion in this case), while positive values represent deposition. The figure was produced using structure from motion photogrammetry processed in Agisoft Photoscan[®] and GCD 6 for ArcGIS[®]. This DoD has not been classified to separate out vegetation or water and it has not been yet adjusted to account for uncertainty (i.e. minimum level of detection threshold of 0.5 m).

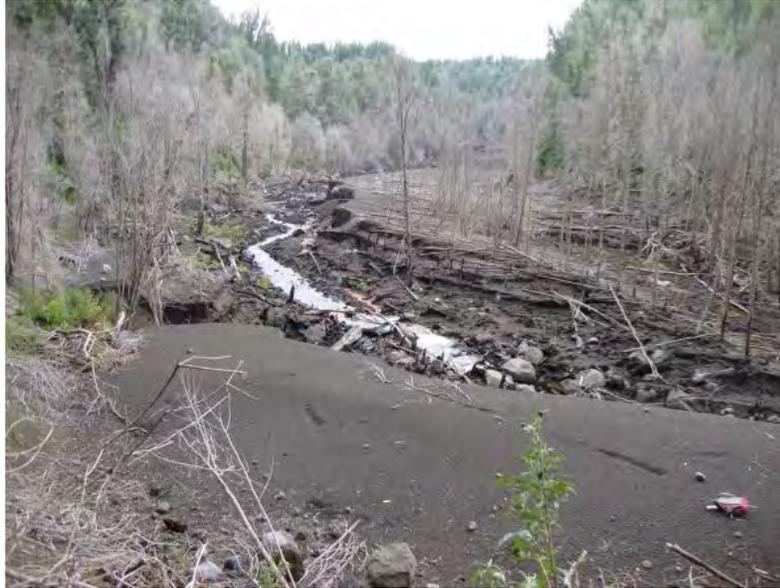
Fig. 6. Tepú River looking upstream in January 2017. Note flat, primary deposit surfaces.

- Setting the stage (Fig. 6). Multiple pyroclastic flows came down the valley and left deposits of 2-8+ m total thickness on the valley floor, partially burying young forest which probably date from similar events in the 1961 eruption. Unlike the broad head of the Blanco-Este River watershed, the Tepú River heads in a very narrow, bedrock-lined, and steep basin, so eruption column collapse and hot scoria that fell on the slopes mobilized immediately, forming pyroclastic flows that ran down the valley. In the first few years after the 2015 eruption, fluvial erosion has removed a large fraction of these 2015 flow deposits, exposing the pre-eruption channel, stream banks, and pre-eruption soil surface in some areas. There has not been the massive influx of alluvium from upstream sources which we observe in the Blanco-Este River, so the channel in this reach appears to be in its pre-eruption location (note root systems of killed, pre-eruption streamside vegetation marking the location of the stream banks).

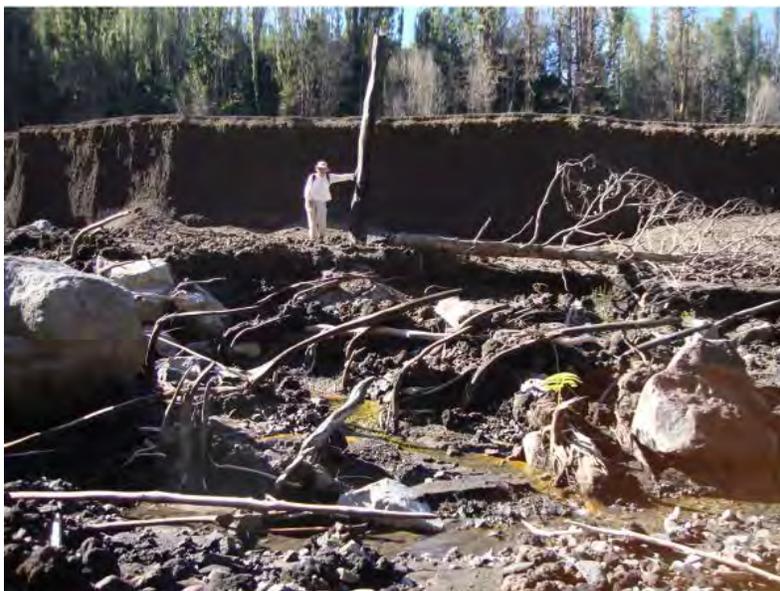
Fig. 7. Tepú River. The hot flows bent over small trees (foreground) and the ends of these stems were cooked to charcoal and abraded; the large tree remained upright, but burned at the top of the hot deposits and its top fell downstream after fluvial erosion of the new deposits.

- Effects of hot flows on trees. The hot flows bent over small trees (diameter less than ca. 12 cm) and the ends of these stems were cooked to charcoal (Fig. 7). It appears that the upper parts of these small trees were removed by abrasion by bedload transport as the river eroded and transported the new flow deposits. In some areas, larger trees (diameter greater than ca. 15 cm) extended above the top of the deposits (Fig. 7). Some of those trees burned at the top of the deposits and the tree tops generally fell in the down-valley direction (possibly in response to

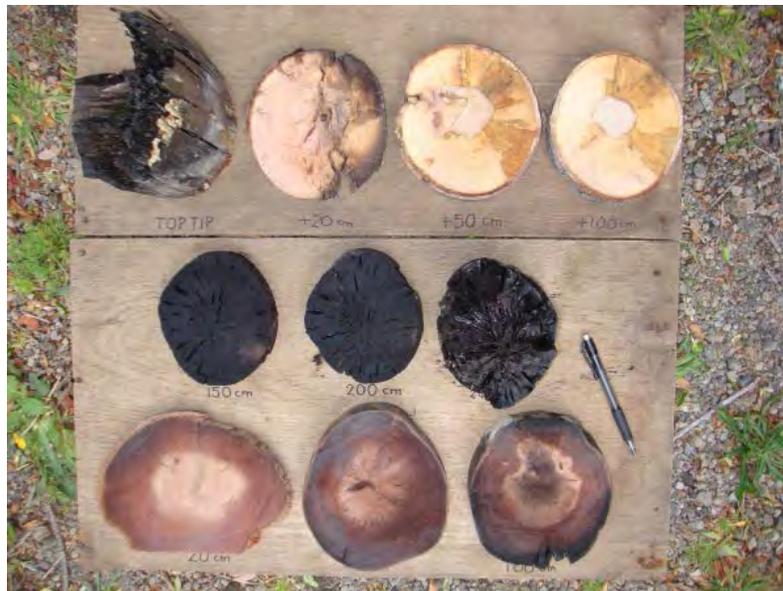
Fig. 8. Sections of a standing tree with increasing heat damage higher above the pre-eruption forest floor (lower left is 20 cm above ground level) to the top of the new deposits (right side, center row); upper left section is base of the fallen top; upper right section is 100 cm higher.

slight down-stream tipping by the hot and cold flows). Sections (cookies) cut from the standing trees reveal a pattern of increasing heat damage (charring, radial cracking) with height above the pre-eruption forest floor to the top of the new deposits (Fig. 8), suggesting that evaporation of water from the buried soil, tree stems, and streambed may have created a thermal gradient with more rapid cooling close to the base of the deposits.

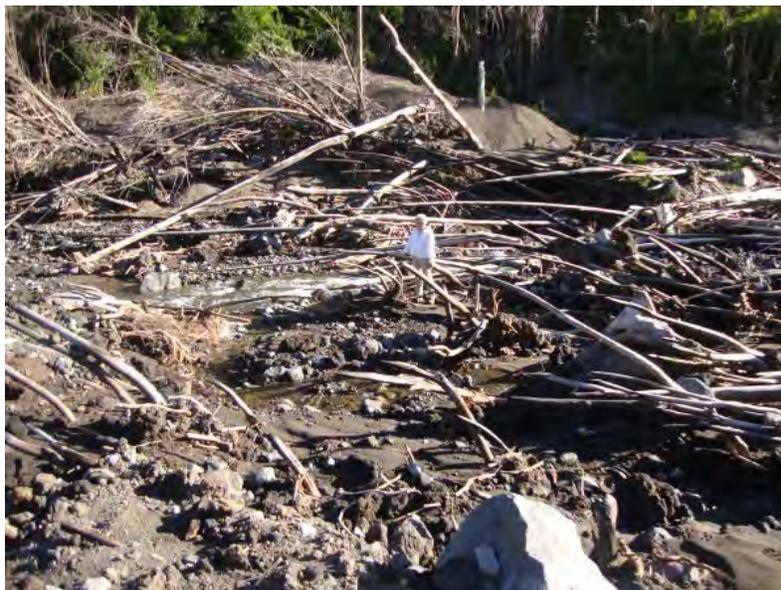
Fig. 9. Tepú River hot flows toppled many trees in the downstream direction, but most of these wood pieces are still partially rooted and suspended above the valley floor.

- Wood in the river. Overall, many pieces of large dead wood are on the valley floor of the lower km of the channel in this zone of hot flow deposits; however, an inventory of wood revealed very few free-to-move pieces in the channel. In some areas, the hot flows toppled many trees in the downstream direction, but most of these wood pieces are still partially rooted and suspended above the valley floor, so they do not perform the geomorphological and ecological functions we typically expect of large wood in rivers (Fig. 9). Will eventual decomposition of the root systems result in delayed wood input to the river? Since the eruption, landslides from outside the reach of the hot flows have been important sources of large wood to the river and valley floor more generally.

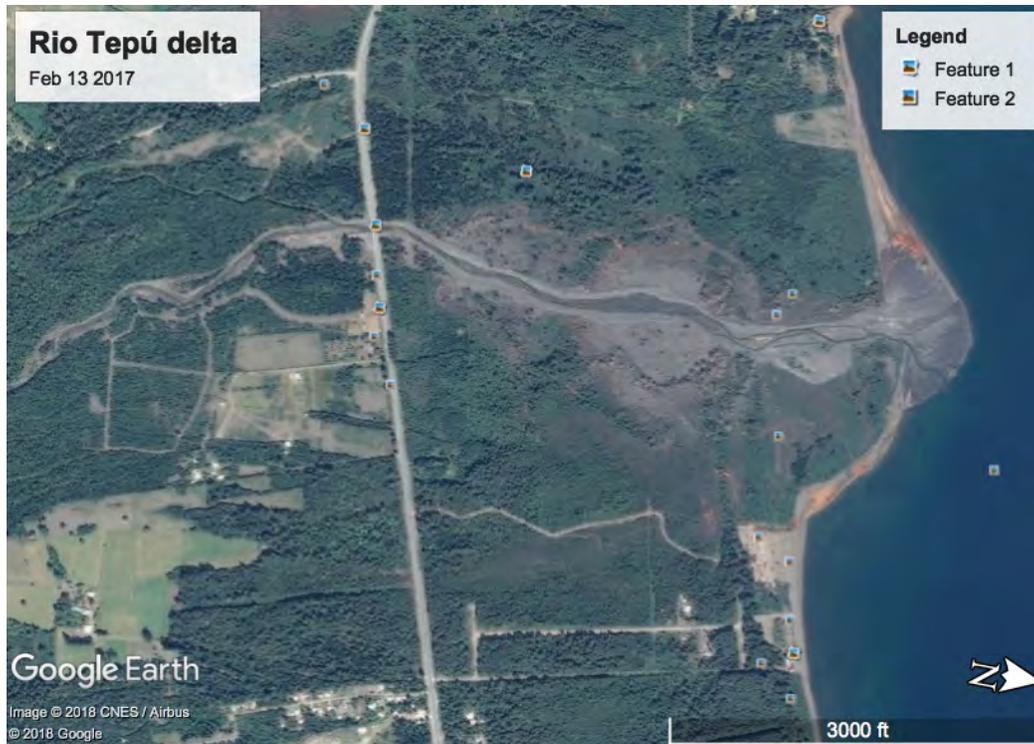
Fig. 10. Tepú River extensive deposition into floodplain forest and constructing a small delta into Llanquihue Lake.

- Downstream transport of sediment. The hot flows extended downstream and stopped at the upstream end of the island partially covered by living trees, where the very steep section of our trail reaches the valley floor. Downstream of this island the floodplain is covered with several meters of fluvially-emplaced sediment derived from erosion of the flow deposits. The downstream and lateral extents of this remobilized sediment decrease over a kilometer or two below the island; downstream of that point the channel gradient is sufficiently steep over several additional kilometers to transport sediment derived from the flow deposits without leaving significant, post-eruption deposits in the channel or on the floodplain. As the Tepú River approaches within a few kilometers of Llanquihue Lake, its gradient decreases, making possible extensive deposition into floodplain forest, endangering the Highway 255 bridge, and constructing a small delta into Llanquihue Lake (Fig. 10). We can view the conditions of the river and floodplain in the transportation zone (a few hundred meters downstream of the small bridge into the Parque Valle los Ulmos) and at the Highway 255 bridge as we depart the Ensenada area. We have not surveyed the Tepú River for large wood, but it is extremely sparse in the sites we have visited.
